## Failed Façade Tectonics - Slab Deflection Joints

**Summary:** A project that we previously photographed during construction, started exhibiting the anticipated failures. It's one of the most typical architectural issues: disregard for slab deflection joints in façade design.

**Relevant Links for the SEVENTH AVENUE TRANSIT VILLAGE at 6101, 6145, and 6145 NW 7TH AVE, Miami, FL 33127:**

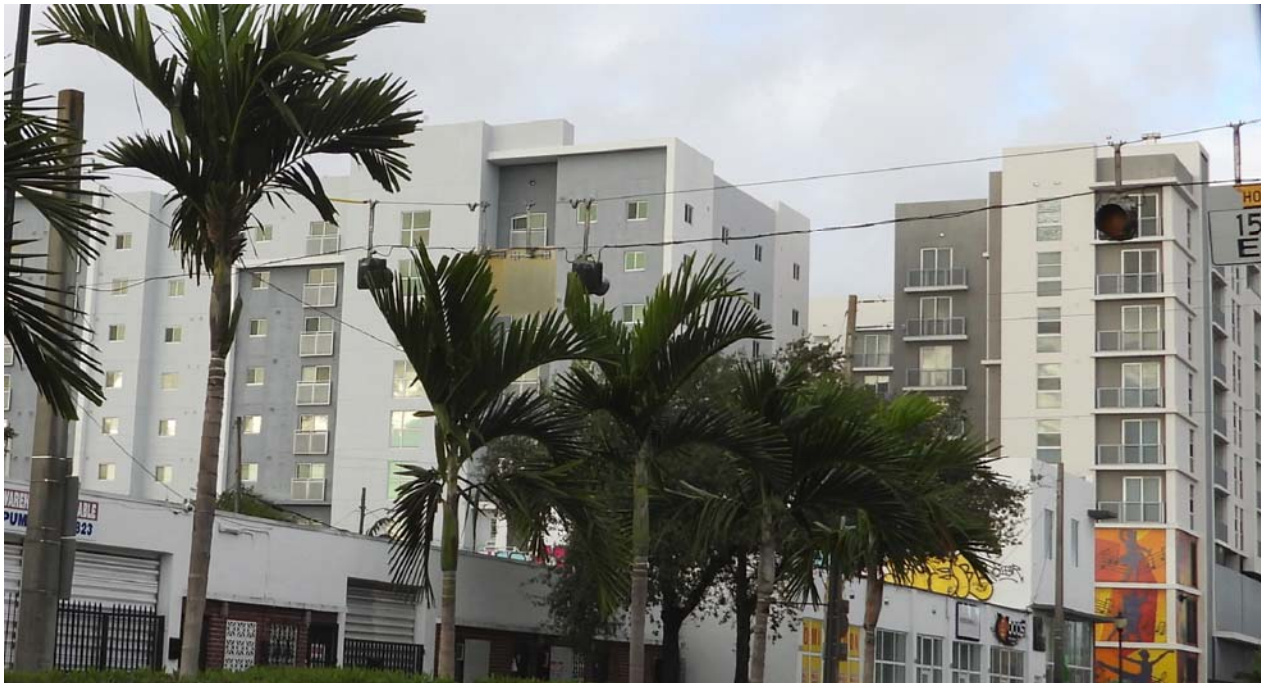
General Photographs. East Elevation. Visible stains and cracks.

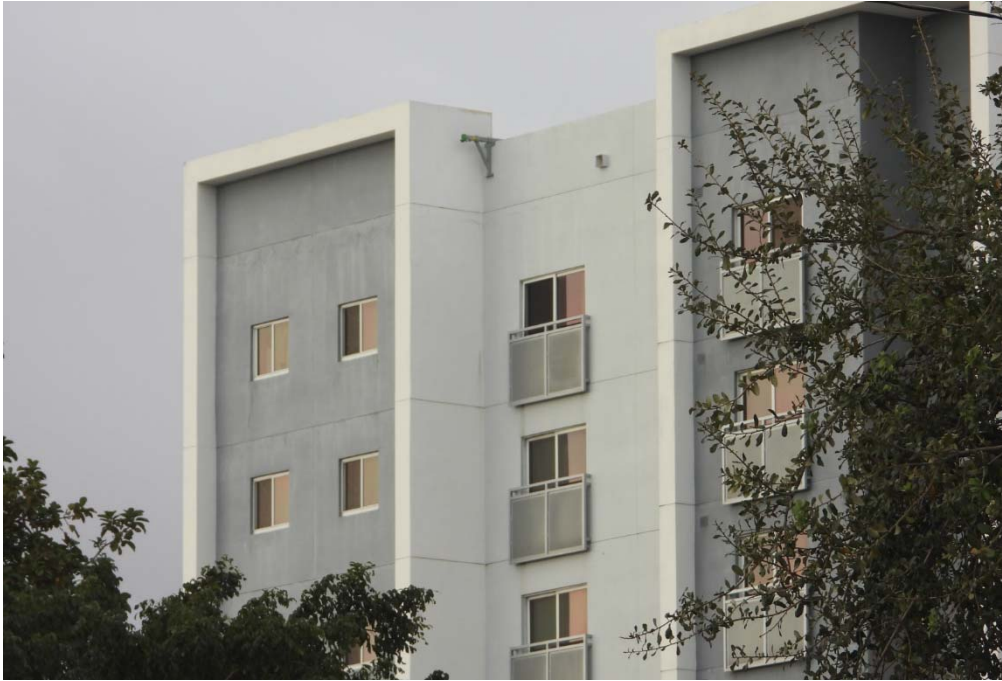
East Elevation. Typical. Visible stains and cracks along the unaddressed slab deflection joints and additional cracks propagating from corners of openings. Also visible efflorescence.

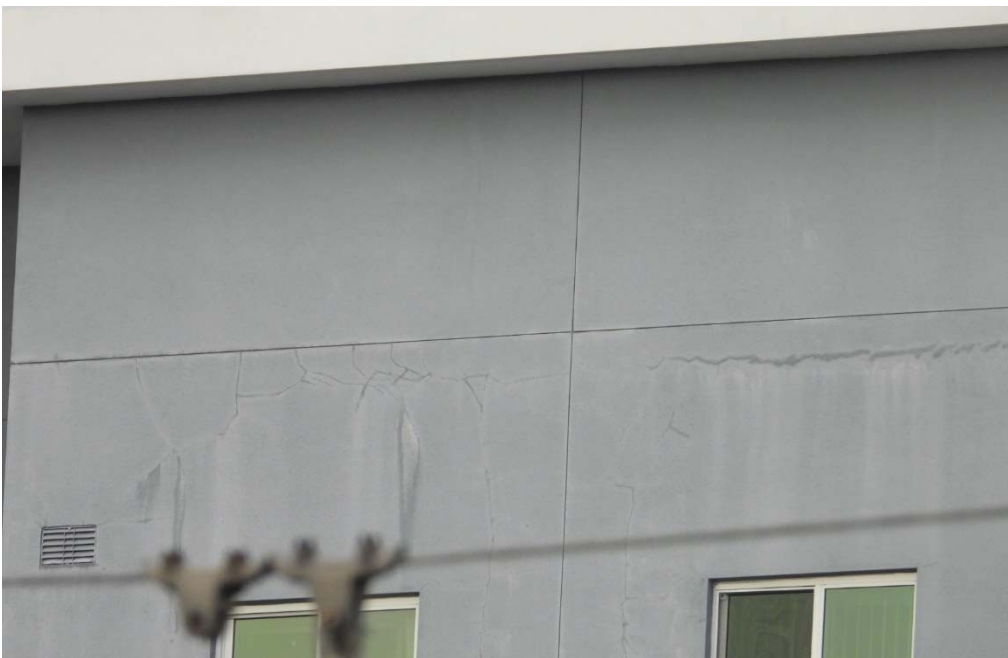
East Elevation. Typical. Visible stains and cracks along the unaddressed slab deflection joints and additional cracks propagating from corners of openings. Also visible efflorescence.

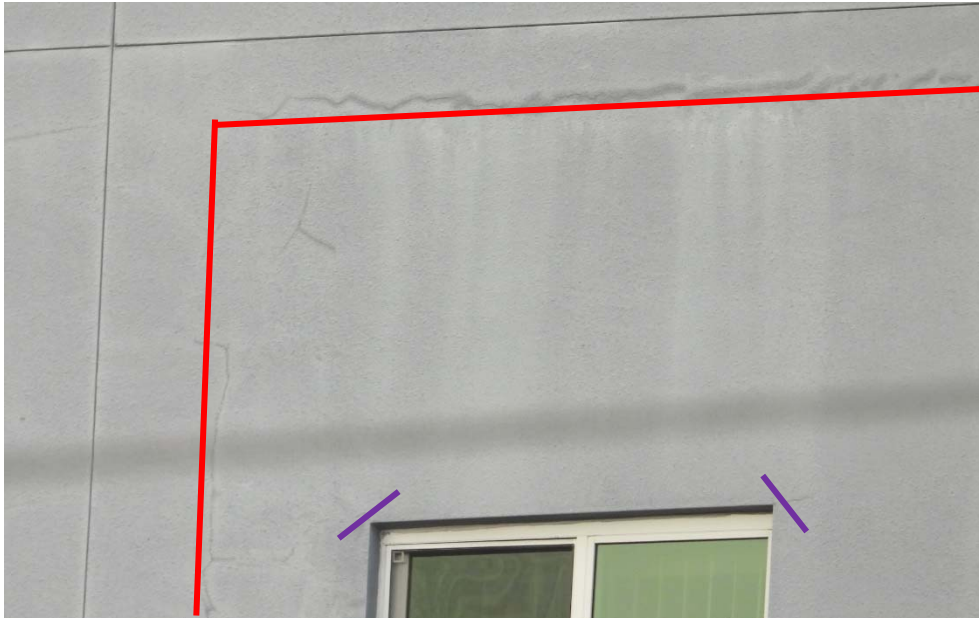
East Elevation. Further Magnification. Typical. Visible stains and cracks along the unaddressed slab deflection joints and additional cracks propagating from corners of openings. Also visible efflorescence. The red line marks the unaddressed slab deflection joint (vertical portions are shoulders of masonry walls). That's where the movement joints in the finish layer should had been placed to control the cracking. Purple lines indicate the missing/inadequate diagonal reinforcement based on appearance of diagonal cracks propagating from corners of openings.

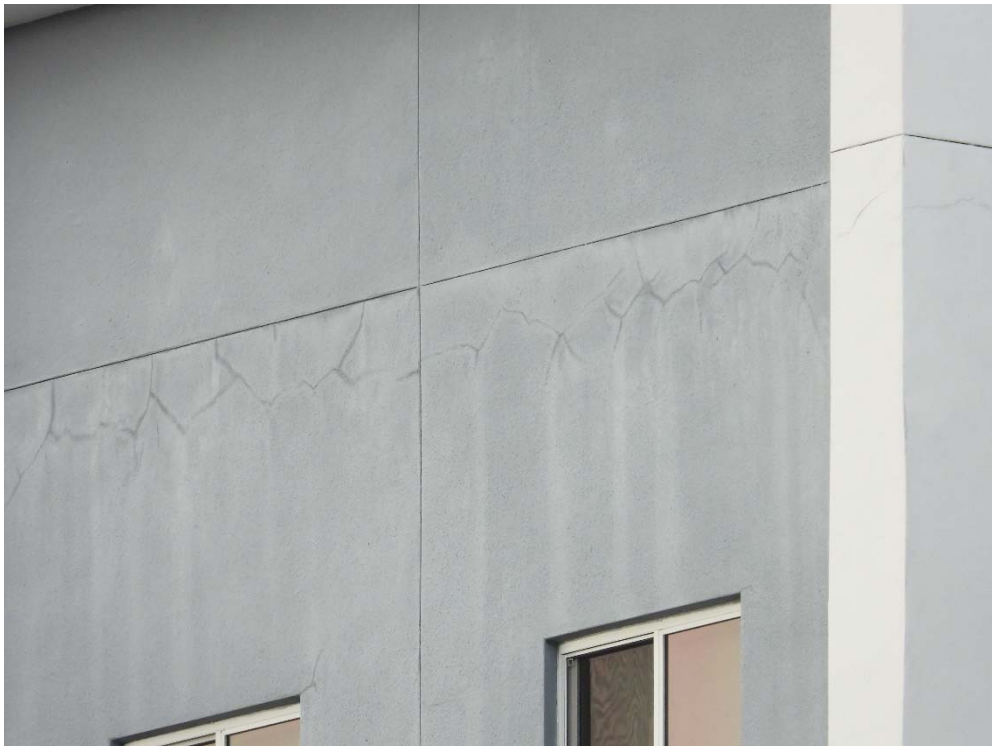
Typical. Visible stains and cracks along the unaddressed slab deflection joints and additional cracks propagating from corners of openings. Also visible efflorescence. Control joints appear to partially participate, making the crack pattern less linear.

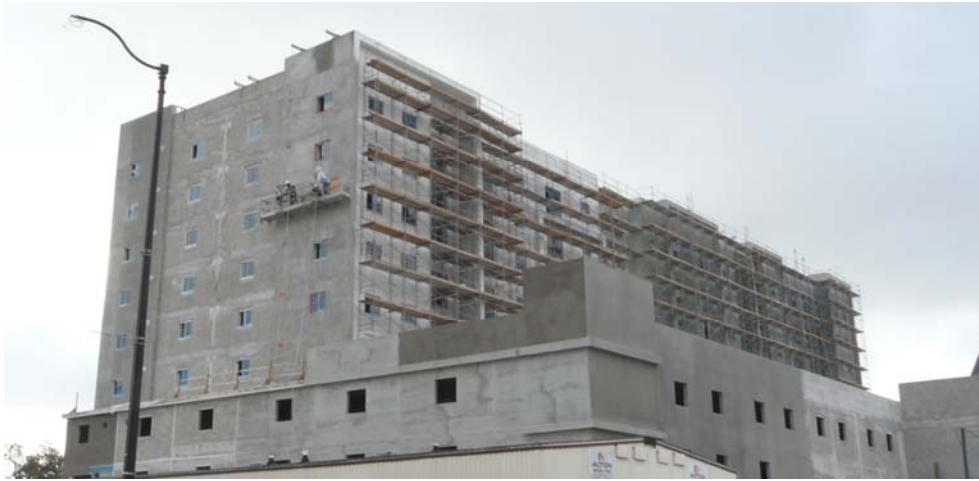
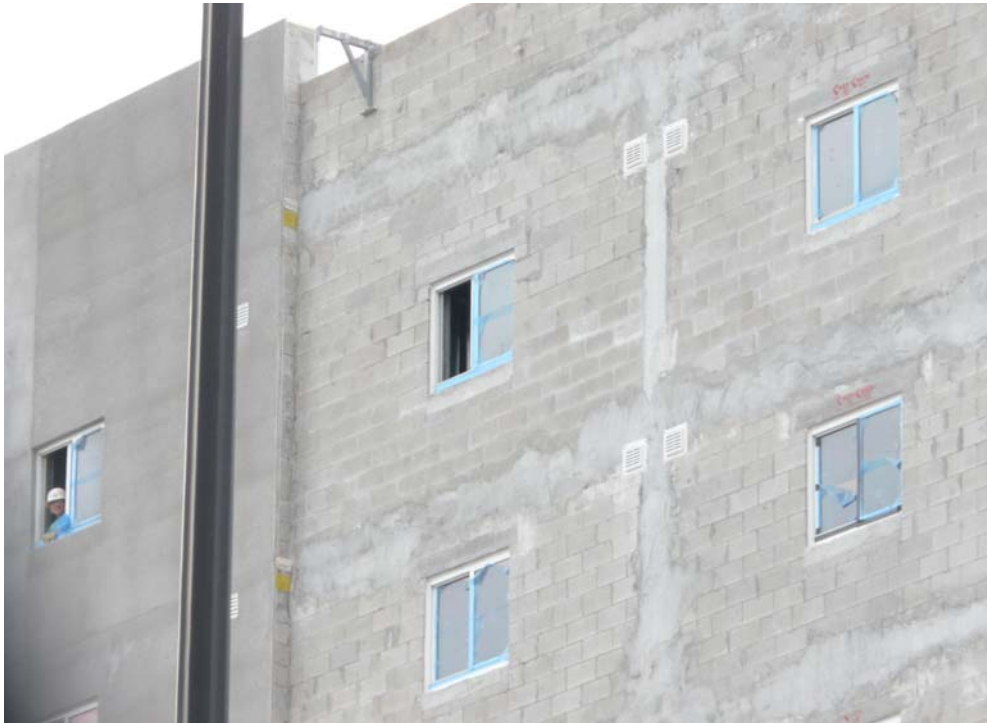
03/24/2015. Photos taken during construction. Visible misaligned slab deflection joints and horizontal control joints, the former left unaddressed. We found no weather resistive barrier on the façade, nor any flashing to address water drainage. These were the reasons why we took these photographs, expecting there would be some educational content in showing the history of this façade later, compared with photos of anticipated future failures. We were not dissatisfied.

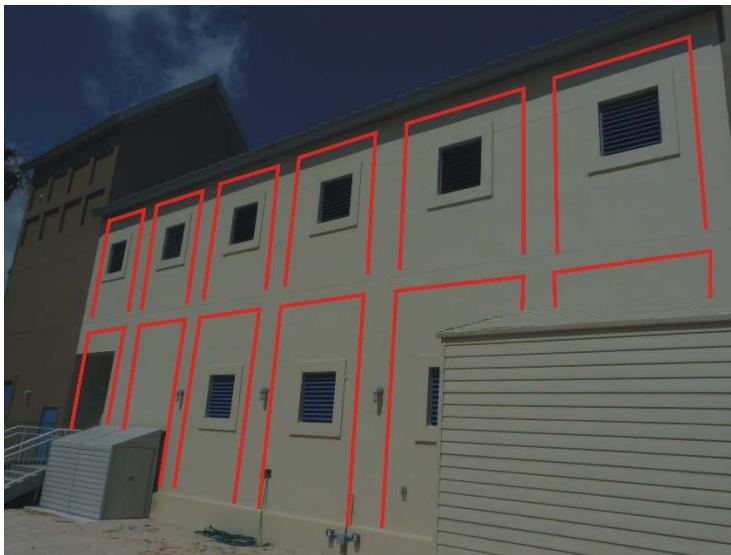
The following is a relevant slide from our seminar titled “Greening Building Envelopes,” also illustrating the unaddressed slab deflection movements in a stucco façade:

The red line marks the unaddressed slab deflection joint (vertical portions are shoulders of masonry walls).
