## Failed Façade Tectonics - Slab Deflection Joints

**Summary:** A project that we previously photographed during construction, started exhibiting the anticipated failures. It's one of the most typical architectural issues: disregard for slab deflection joints in façade design.

**Relevant Links for the SEVENTH AVENUE TRANSIT VILLAGE at 6101, 6145, and 6145 NW 7TH AVE, Miami, FL 33127:**

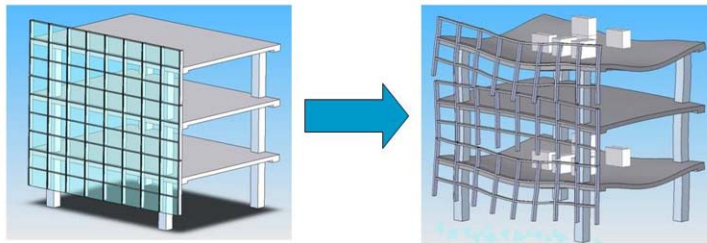
## Accommodating Building Movement

Here is a relevant slide from our seminar titled “Principles of Façade Design,” illustrating the slab deflection movement, and the resulting need for such joints:
